TECHNICAL EQUIPMENT REPORT NO. F-4 APRIL 1959

MODIFICATIONS OF THE U.S.F.S. MODEL 52A FIRE LINE TRENCHER

ROBERT R. LINDAHL AND DAVID B. KIBLER FOREST SERVICE, U. S. DEPARTMENT OF AGRICULTURE JEFFERSON NATIONAL FOREST, VIRGINIA

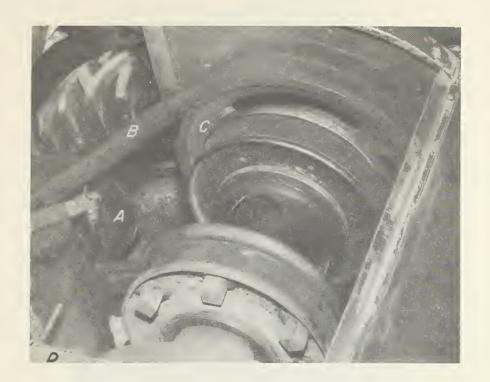
The dog-type clutch has been a major source of trouble. The sudden shock when the clutch was engaged made it impossible to get more than 4 hours of trouble-free operation. To overcome this sudden engagement and to free the motor of a slight drag from the forward and reversing clutch, a centrifugal-type master clutch was installed on the left side of the engine drive shaft (figs. 1, 2, and 3). This was a 3-1/2-inch clutch with double V belt pulley having a horsepower range of 5 to 7-1/2 (Sears #32A318).

Figure 1.--A, Centrifugal clutch; B, double V belt; C, double V, 7.8 inch pulley; D, wing nut bolt for holding down metal cover.

Before installing the clutch and necessary pulleys, the engine crank-shaft had to be lengthened 1-1/2 inches and the motor moved 1-1/8 inches to the right. Slotted holes provided for the motor mounting served as a means for adjusting the main drive belt. The sprocket and chain were replaced by a 7.8-inch double V pulley (Sears #9A2904) and two belts (Gates #223 Tr. 11/16 x 42-inch). The 7.8-inch pulley is mounted to the left side of the forward and reversing clutch. Approximately 1/16 inch had to be planed from one side of the 7.8-inch pulley to provide clearance between it and the frame.

At the time this report was prepared, the centrifugal clutch had operated 10 hours satisfactorily. It apparently has corrected the faults of the dog-type clutch.

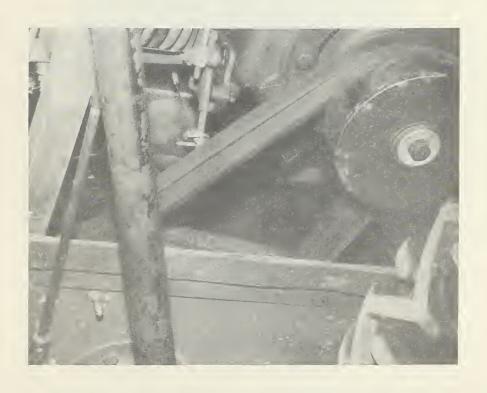
Figure 2.--Side view (left) of clutch mount.
